Intel® 31154 133 MHz PCI Bridge

Specification Update

December 2005

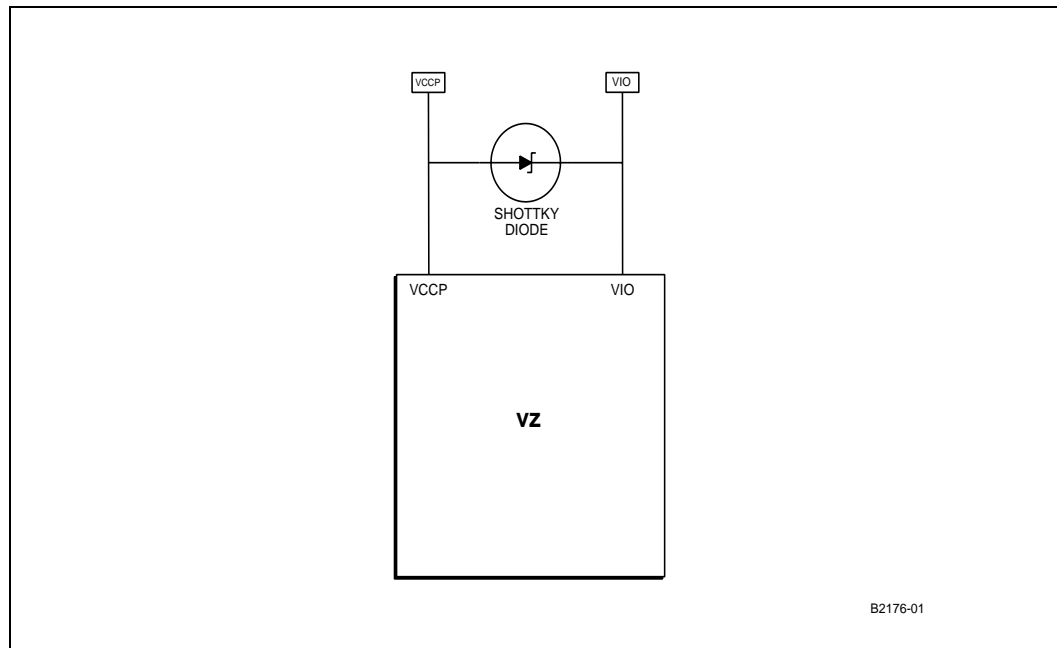
Figure 1. Installing a Shottky Diode

If either P_VIO or S_VIO is not connected to the same power supply as Vccp, the user must perform one of the following steps:

- Ensure that the P_VIO or S_VIO power comes up before or simultaneously with Vccp and ensure that the P_VIO or S_VIO power goes down after or simultaneously with Vccp.
- Install a Schottky diode, as shown in [Figure 1](#), between VCCP and the VIO pin/pins (as appropriate). The diode should be sized appropriately for the system's power environment. **(Recommended)**
- Connect a 250Ohm current limit resistor in series with the P_VIO and S_VIO supply. P_VIO and S_VIO can never be at a lower voltage than VCCP except in the case of a 250Ohm current limiting resistor in series with the P_VIO and S_VIO supply.

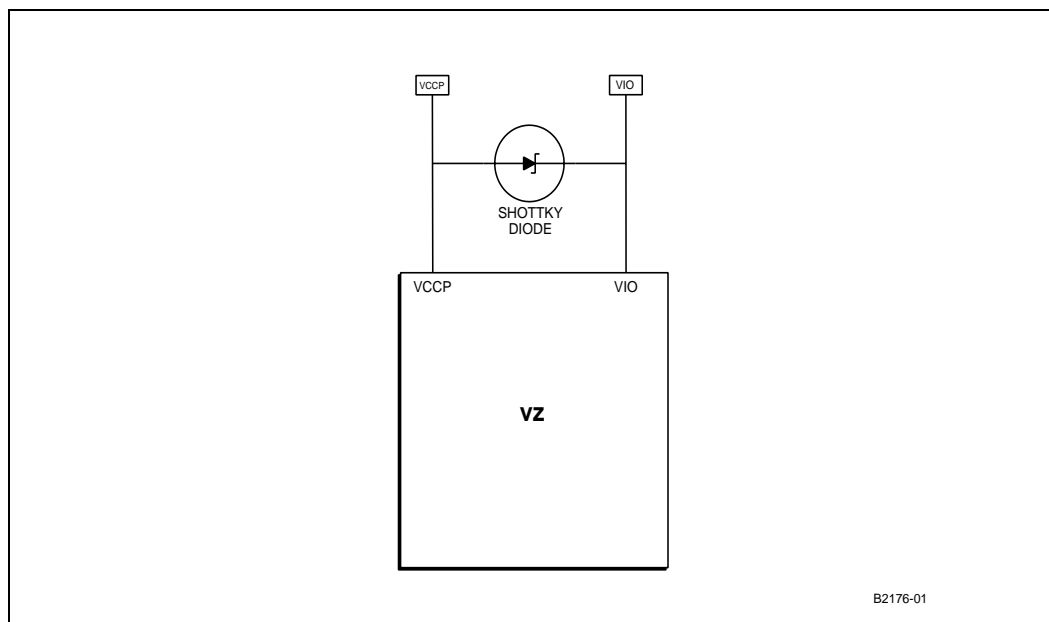
Figure 2. Installing a Shottky Diode

Issue: The description for Section 3.4 does not fully describe the powering sequence for the 31154 Bridge. It should appear as follows:

If either P_VIO or S_VIO is not connected to the same power supply as Vccp, the user must perform one of the following steps:

- Ensure that the P_VIO or S_VIO power comes up before or simultaneously with Vccp and ensure that the P_VIO or S_VIO power goes down after or simultaneously with Vccp.
- Install a Shottky diode, as shown in [Figure 2](#), between VCCP and the VIO pin/pins (as appropriate). The diode should be sized appropriately for the system's power environment. **(Recommended)**
- Connect a 250Ohm current limit resistor in series with the P_VIO and S_VIO supply. P_VIO and S_VIO can never be at a lower voltage than VCCP except in the case of a 250Ohm current limiting resistor in series with the P_VIO and S_VIO supply.
